# AN10608

## XTAL1 clock and $\overline{\text{IOW}}$ pulse synchronization issue

Application note

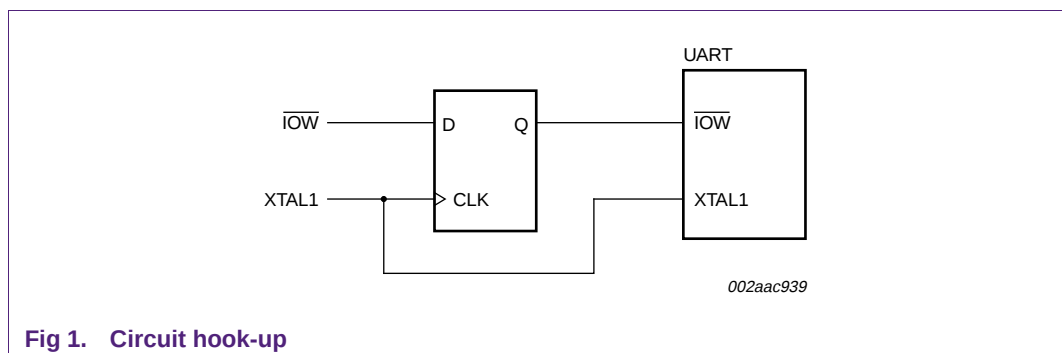
There is an internal signal that indicates the availability of a new character in the transmitter FIFO, and that signal is clocked by the processor  $\overline{\text{IOW}}$  pulse. In the non-B UART design, that signal is not synchronized to the XTAL1 clock before it is being used in the transmitter state machine; there exists a race condition between the XTAL1 clock and the  $\overline{\text{IOW}}$  pulse. If the  $\overline{\text{IOW}}$  pulse happens during the time the state machine's input flip-flops are being switched, then the state machine will get into the wrong state. The state machine should be in the start state, but it wrongly jumps to the transmit bit 4<sup>th</sup> state. The transmitter then wrongly sends out the last four bits of the old character without a start bit, and the rest of the characters in the transmit FIFO.

1. Replace the non-B revision with the B revision devices.
2. The hardware work-around for this issue requires an external flip-flop to synchronize the  $\overline{\text{IOW}}$  pulse to the XTAL1 clock. XTAL1 is used to clock the D flip-flop. The  $\overline{\text{IOW}}$  signal from the processor is connected to the D input of the flip-flop, and the Q output of the D flip-flop is connected to the  $\overline{\text{IOW}}$  input of the UART. See [Figure 1](#) for the circuit hook-up example.
