# ES\_LPC435x/3x/2x/1x Flash

## Errata sheet LPC435x/3x/2x/1x flash-based devices

Rev. 6.8 — 24 September 2019

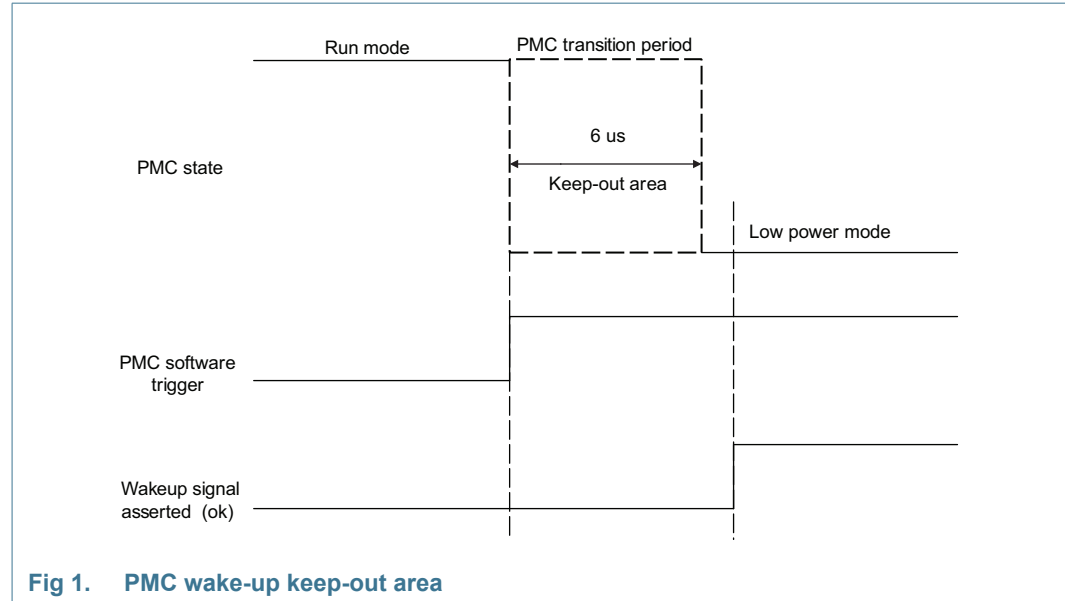
Fig 1. PMC wake-up keep-out area

When the chip is in a transition from active to Deep Sleep, Power Down, or Deep Power Down, wake-up events are not captured and they will block further wake-up events from propagating. The time window for this transition is 6  $\mu$ s and is not affected by the chip clock speed. After a wake-up event is received during the PMC transition, the chip can only recover by using an external hardware reset or by cycling power.

Make sure that a wake-up signal is not received during the Deep Sleep, Power Down, or Deep Power Down transition period. An example circuit to work around this could include an external 6  $\mu$ s one shot which could be triggered via software using a GPIO line when entering Deep Sleep, Power Down, or Deep Power Down mode. The one-shot's output could be used to gate the wake-up signal(s) to prevent receiving a wake-up signal during the PMC transition period. Depending on the system design, it may also be needed to latch the wake-up signal(s) so that they will still be present after the one-shot's 6  $\mu$ s time-out.

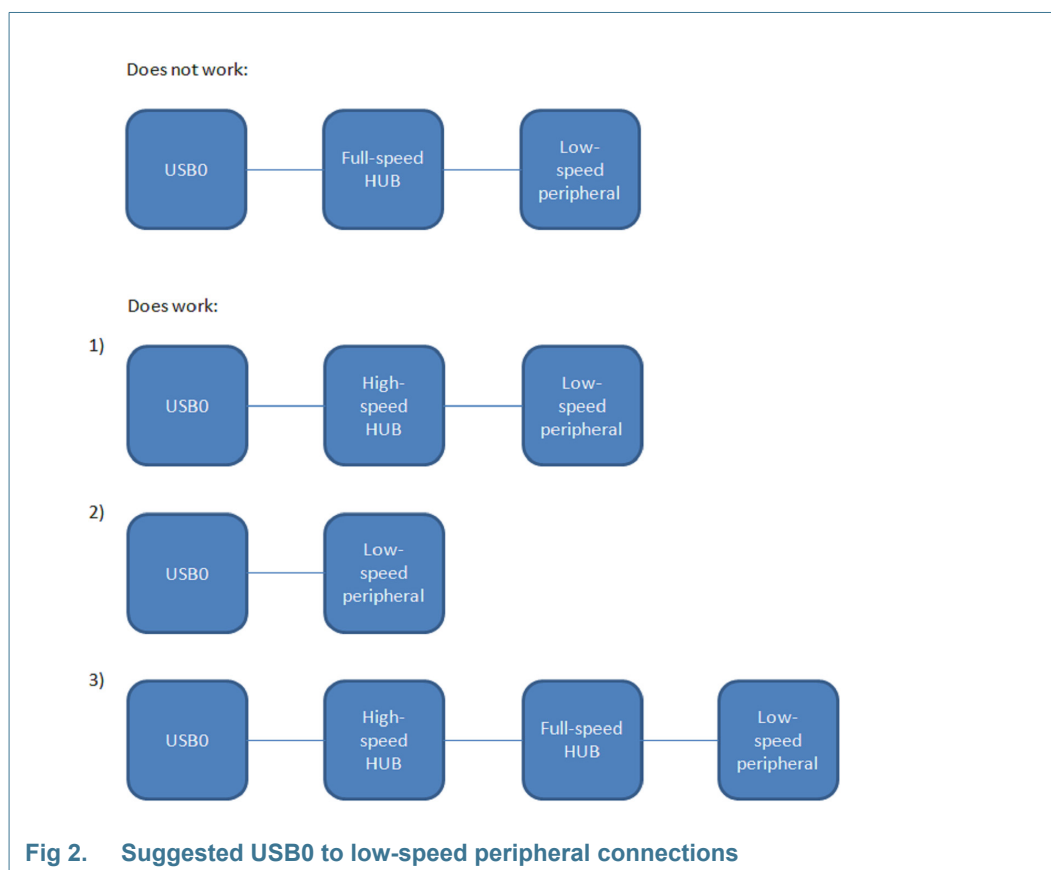
The USB controller called USB0 is unable to communicate with a low-speed USB peripheral in host mode when there is a full-speed hub directly connected to the USB0 port and a low-speed peripheral is connected in the tree somewhere below this full-speed hub. Only USB0 has this problem; the other USB controller, USB1 does not.

There is no work-around for this problem. It is suggested that the low-speed USB peripheral is either connected directly to USB0 or a high-speed hub is placed between that peripheral and USB0.

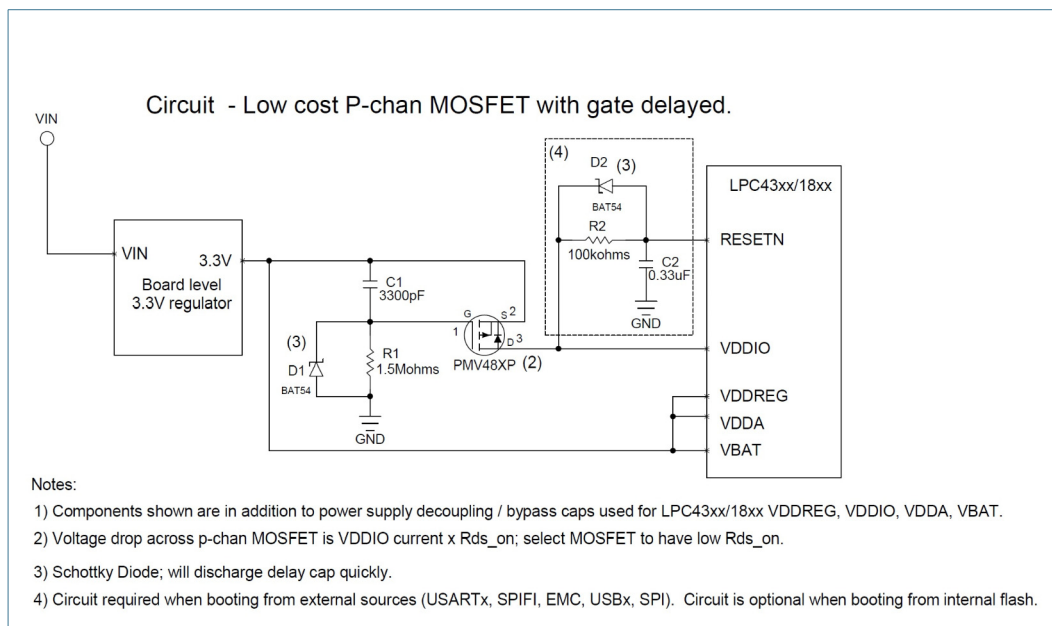
On all packages, repeated power cycling of the device may cause erroneous programming of the OTP banks. During ramp-up, the VDDREG supply voltage does not have enough time to settle and initialize the OTP controller before valid programming voltage is reached on the VPP pin. This may cause accidental programming of the OTP banks. Accidental programming of the OTP banks does not occur during power-down of the supply voltage.

- Boot from internal memory:
  - When VDDREG, VDDIO, and VDDA pins are tied together, the supply voltage must have a linear ramp-up time of at least 2 ms.
  - When VDDREG, VDDIO, and VDDA pins are not tied together, the power supplied to the VDDIO pin should be delayed by 2 ms after the power supply on the VDDREG and VDDA pins stabilizes at the operating voltage level.
- Boot from external sources (USARTx, SPIFI, EMC, USBx, SPI):
  - Do not tie VDDIO to VDDREG and VDDA pins. The power supplied to the VDDIO pin should be delayed by 2 ms after the power supply on the VDDREG and VDDA pins stabilizes at the operating voltage level. The signal to the RESETN pin must also be delayed by 2 ms after the power supply on the VDDIO pin stabilizes at the operating voltage level.

The following circuit diagram is an example that shows the P-channel MOSFET with the gate delayed and the R-C delay circuit connected to the RESETN pin.
