Chip Errata for the i.MX 6ULL

This document details the silicon errata known at the time of publication for the i.MX 6ULL multimedia applications processors.

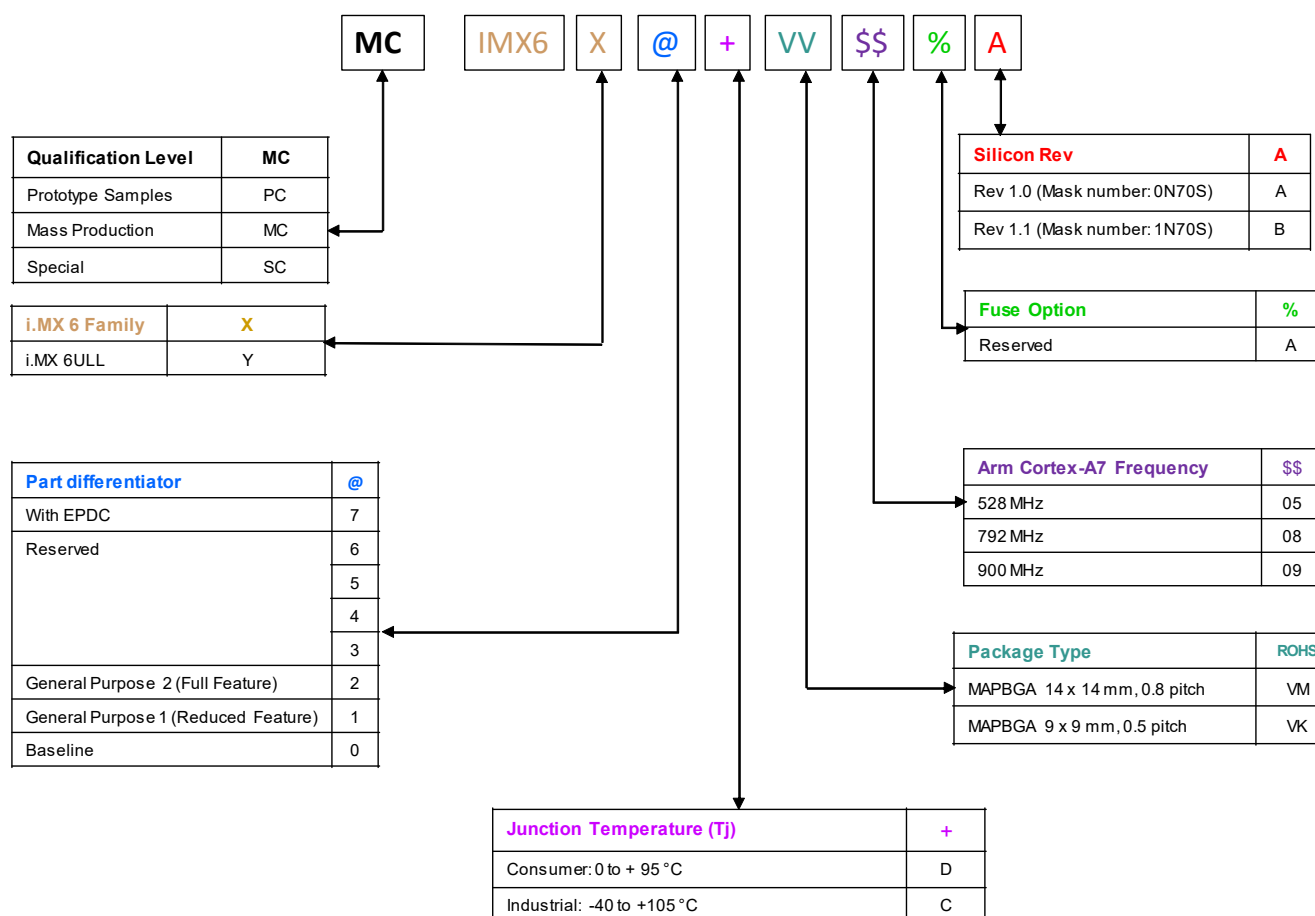
Figure 1. Revision Level to Part Marking Cross-Reference

Figure 1 provides a cross-reference to match the revision code to the revision level marked on the device.
